Biltmore House Entrance Drive Slide Repair

Asheville, North Carolina

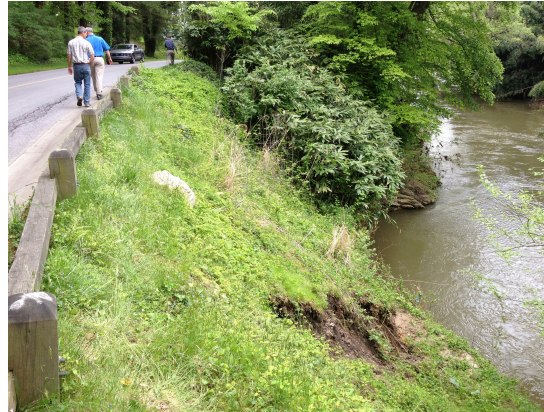
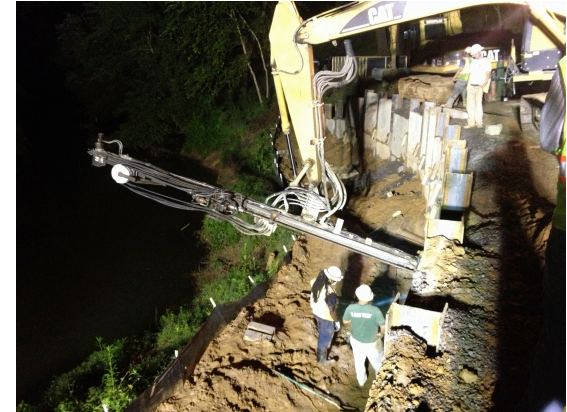
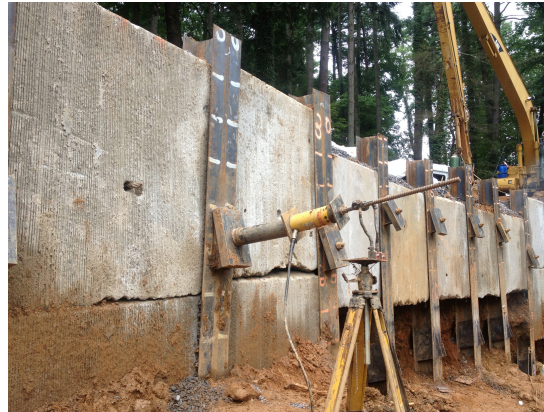
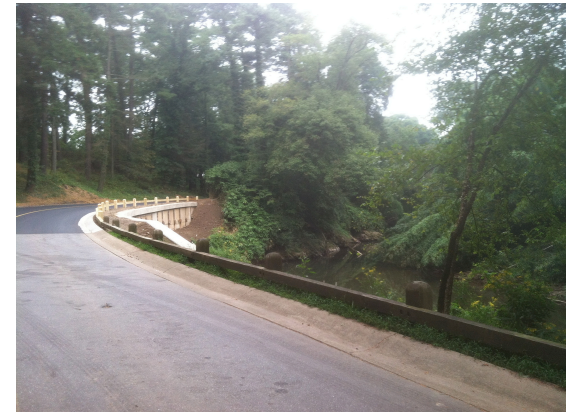
During historic heavy rainfall, a portion of the entrance drive leading to the Biltmore House began to slide toward the river. This road experiences heavy tourist traffic during the day. Emergency repairs were required that would have minimal impact on business.

WEC and NHM Constructors built an H-pile wall with tieback anchors to support the road. WEC chose to work at night when traffic was minimal. As there was insufficient bench to install tiebacks from below the wall, work was performed from the roadway.
