Blue Ridge Parkway, MM 400.8

Asheville, NC

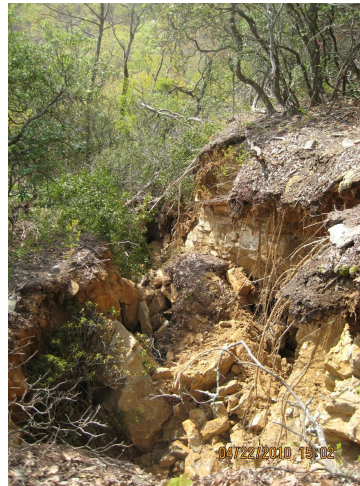
Oak Trees in Tension Cracks
