# Hardison Residence

Leicester, NC

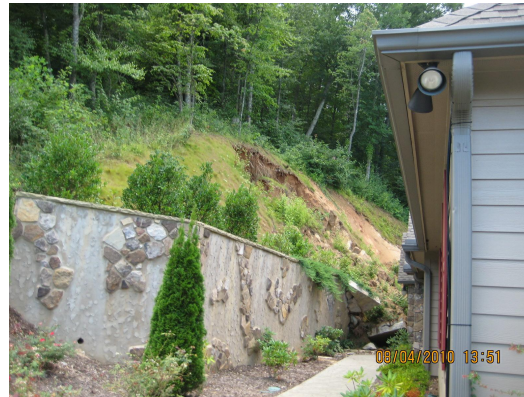
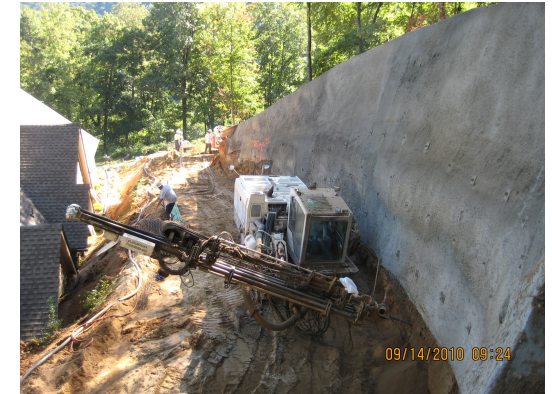
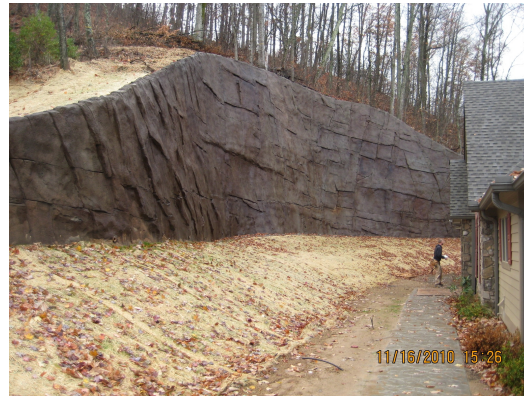
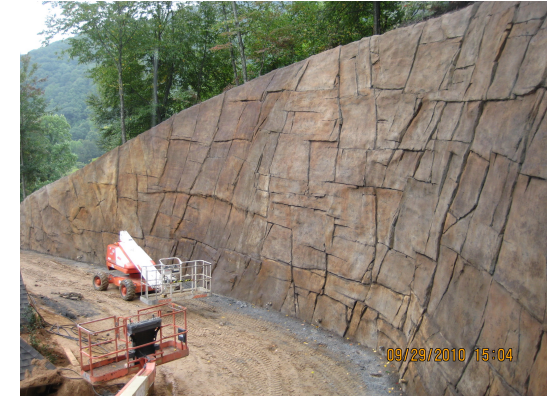
A single family residence was constructed at the toe a soil cut slope inclined at approximately 1H:1V . The soil slope failed and caused a portion of a retaining wall at the toe to collapse, causing damage to the residence.

A soil nail wall was constructed to allow removal of the cast-in-place wall and stabilize the slope. A sculpted and stained finish was applied to blend the retaining wall into the hillside.
