# Lake Keowee Residential Landslide

Salem, South Carolina

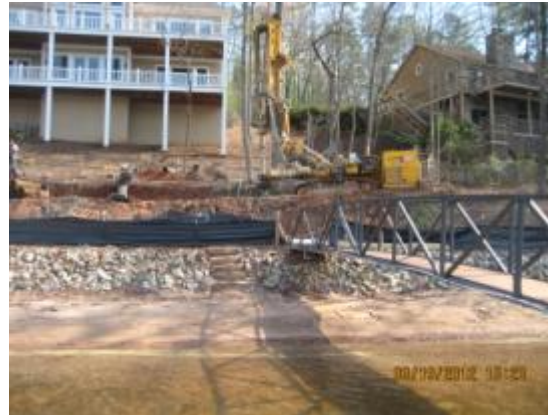
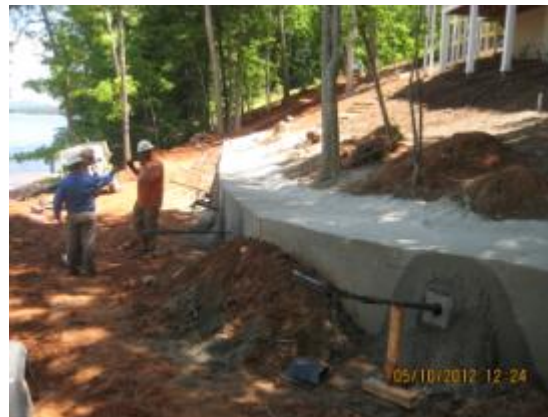
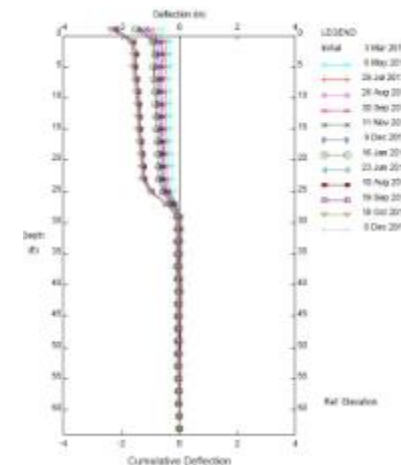
Tension cracks and building distress indicated that a landslide was occurring at a residence on Lake Keowee. Slope inclinometer data indicated that the slide began within the area of the house, terminated in the lake and was about 30 ft deep near the shoreline.

A double line of battered micropiles and a line of tieback anchors were installed near the water line. Slope inclinometer measurements indicate that movement was arrested after installation of the micropiles.

The site has since been landscaped and there is very little evidence of construction repairs.
