Large Retaining Wall Repair

Graham County, North Carolina

Soil Nail Wall

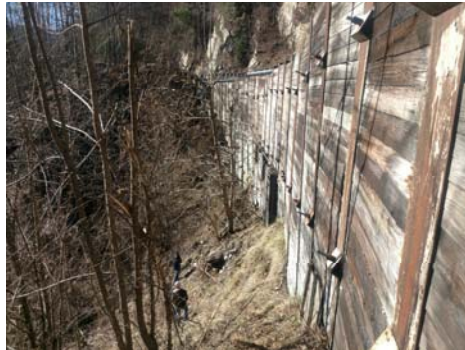
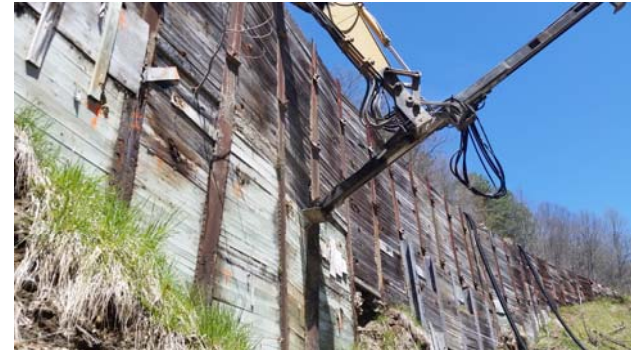
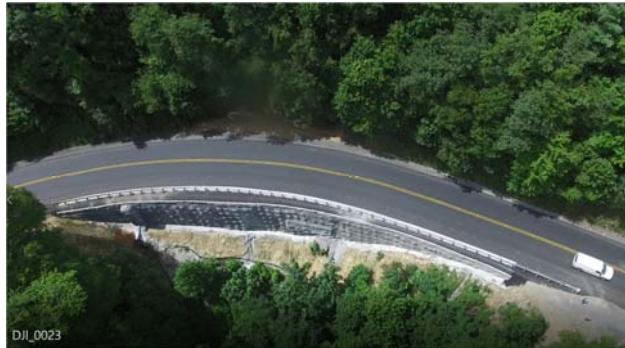
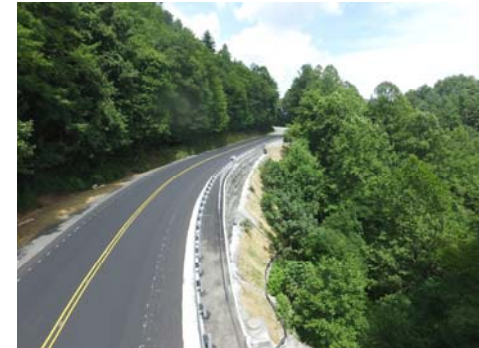
An existing soldier pile and lagging wall was failing resulting in the supported roadway slumping and formation of tension cracks. Soil nails were installed through the existing wall and a reinforced shotcrete façade applied.

The 35 ft tall wall is located a steep hillside and access to the wall with construction equipment was difficult. The repair was completed on time and within budget.
