Buist Academy Seismic Retrofit

Charleston, South Carolina

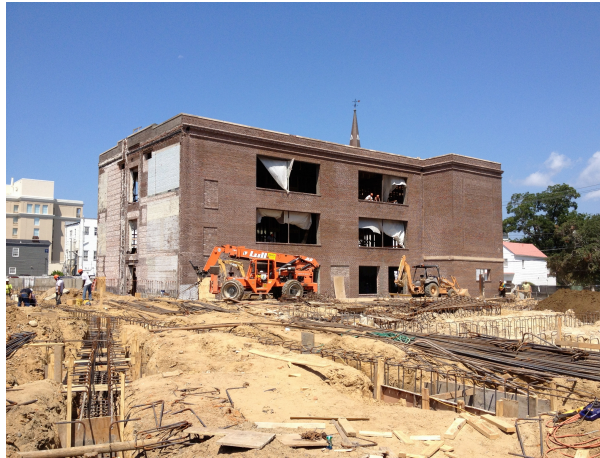
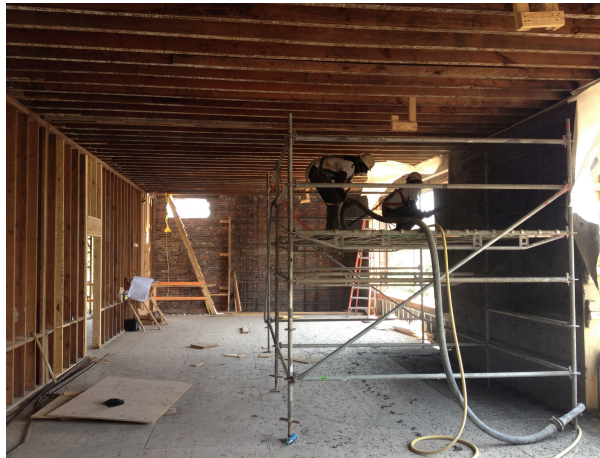
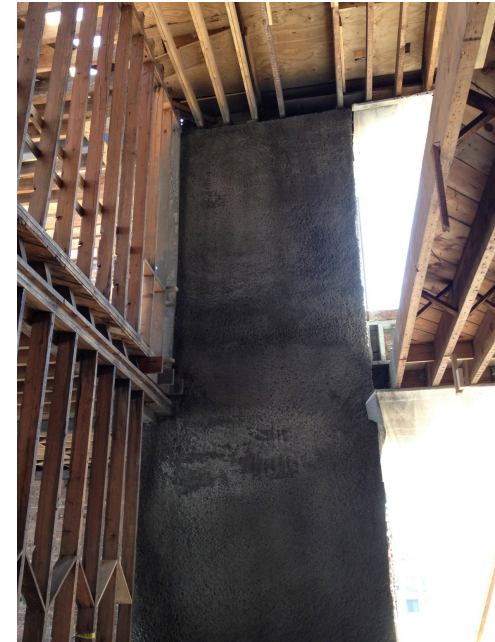
Buist Academy constructed in the late 1800's is being gutted leaving only the outer shell, floor beams and roof. WEC was retained to construct reinforced shotcrete wall overlay for seismic retrofit.

Work is being performed in very tight working conditions on three separate floor levels. A reinforcing cage was constructed and attached to the existing brick walls with hooked and epoxied dowels. The brick walls were brought to a surface saturated dry condition, then shotcrete was applied to the brick walls.
